Microbiologically induced corrosion in cold systems at Forsmark NPP

FOP 7-9 april 2019, Västerås

Massimo Cocco – FKA Material Analysis

Pär Blombergsson – FKA In Service Inspection

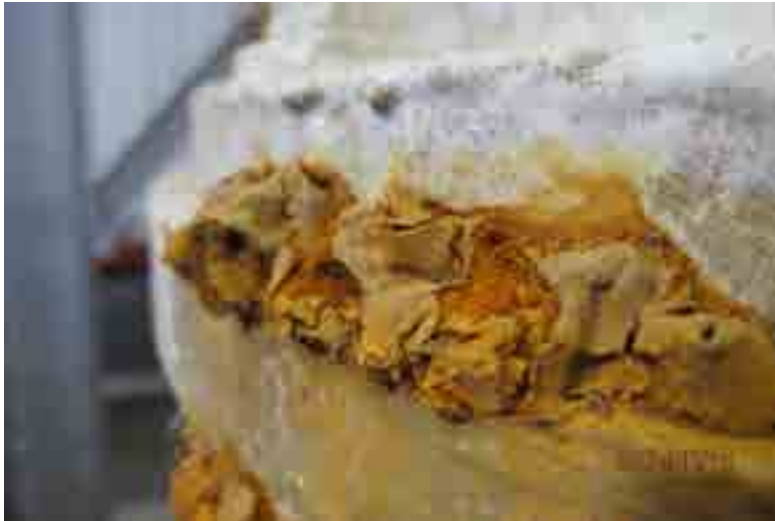
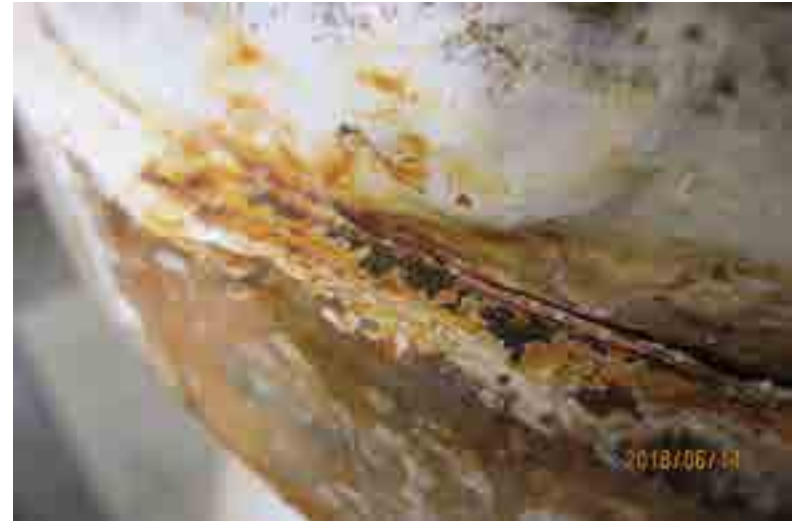
MIC in the cooling water system for the turbin

Voluminous tubercles, but minimal amount of material degradation. The tubercles develops in sheltered places, on painted carbon steel. The distribution pattern on equivalent places appear to be random, although there is a tendency for the tubercles to develop in colonies

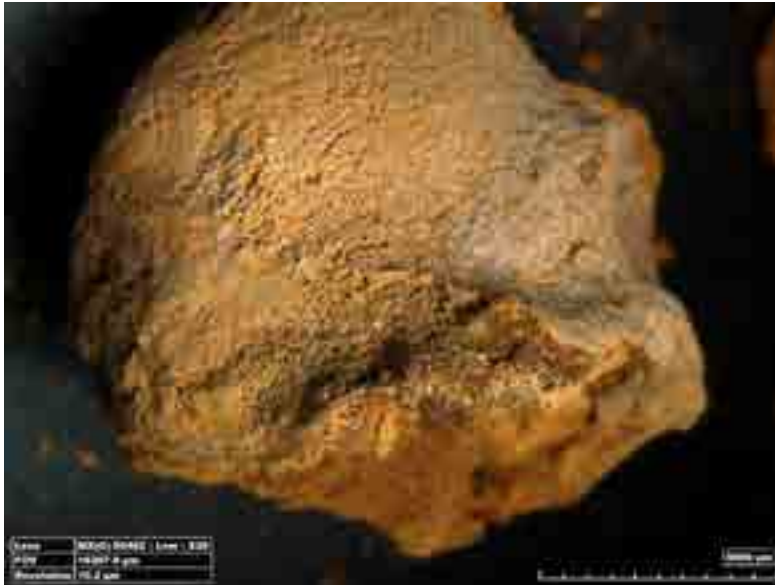
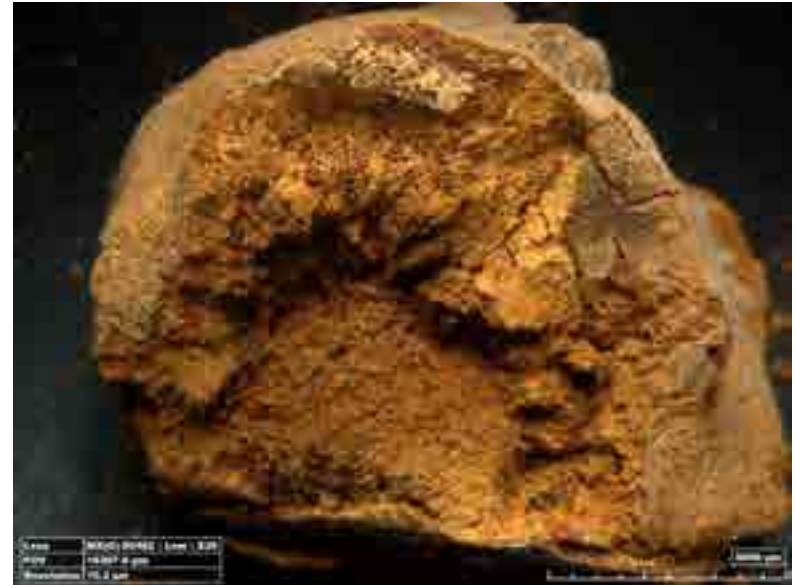
Soft, well defined forms

A thin outer layer covers the tubercles. On the inside the body is spongelike, soft and friable. If powdered it shows an intensive yellow ochre color. This type of MIC bacteria metabolize probably both organic matter and iron ions. The rate of material degradation is so low that it is not expected to affect the mechanical integrity of the components under their designed life time.

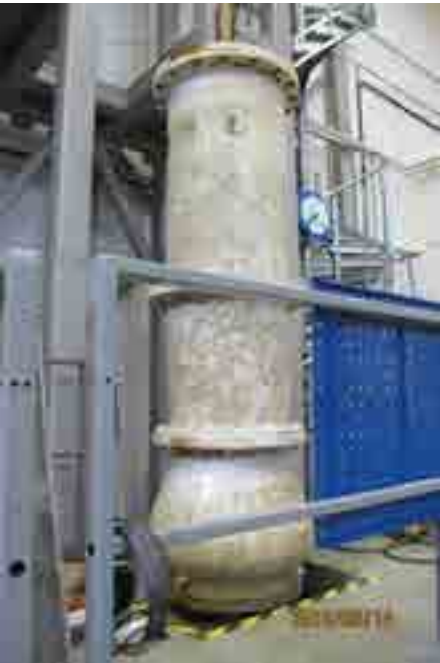
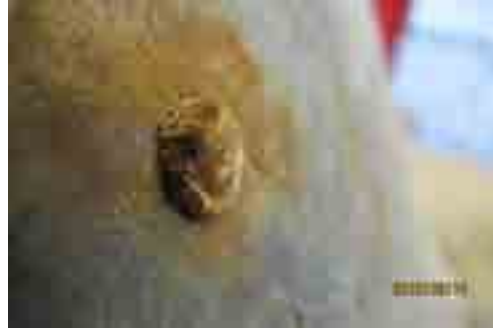
MIC displays different habits on different materials

On the flat surfaces of super duplex cast steel are found small, individual tubercles with hard shell and spongelike core which is partially green colored. They do not cause any significant level of material degradation

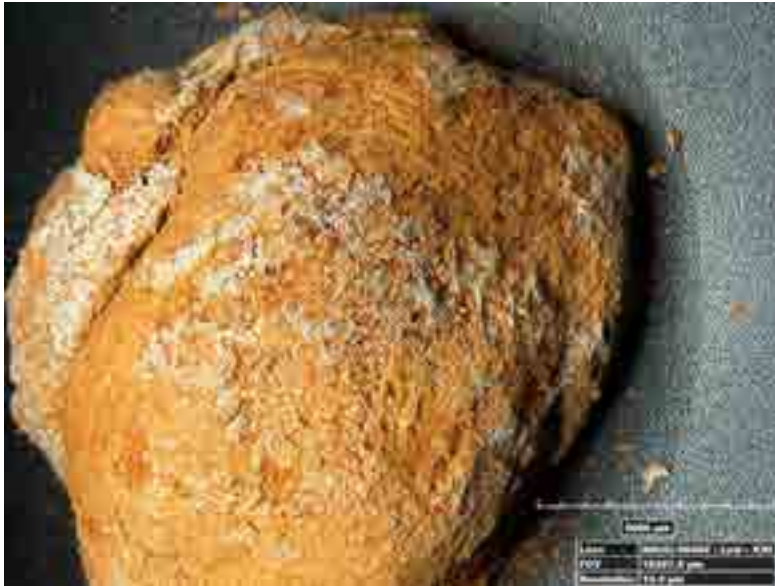
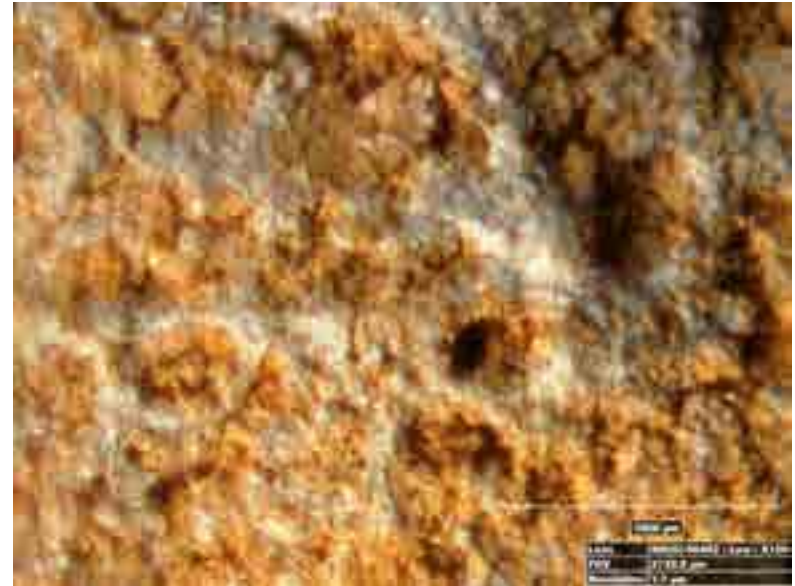
A third type of tubercles

Within the sheltered gaps between the flanges inside the pump house are found well shaped tubercles with well defined canals for exchange between the inside and the outside environment. The base material is painted carbon steel.

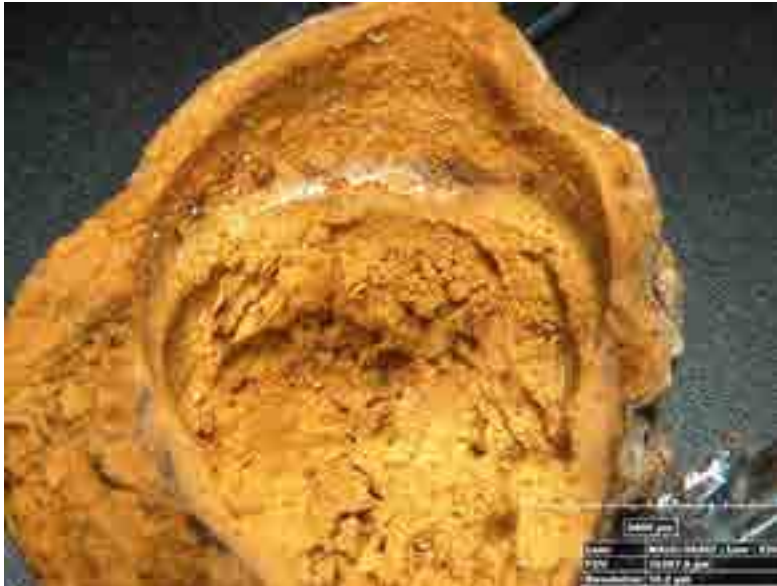
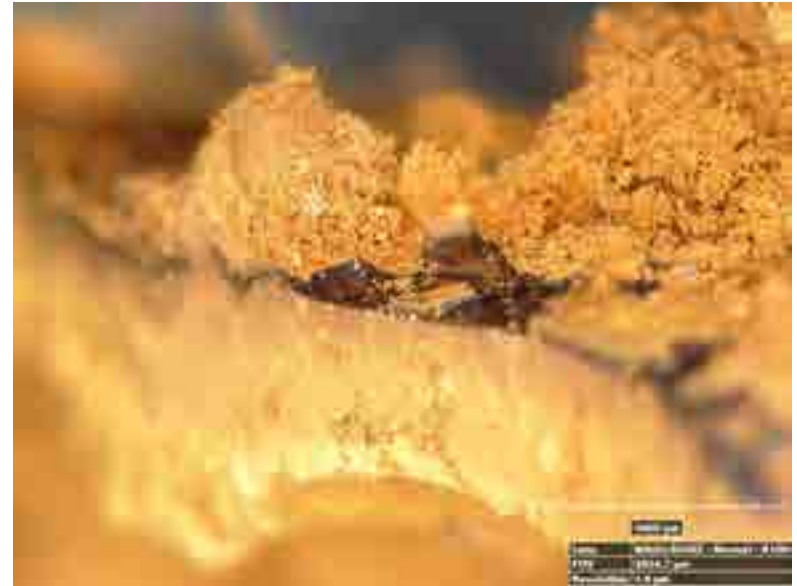
Well defined features

The tubercles display some remarkably regular features. The inside is hollow, with walls that in some parts display uniform thickness, which appear to be defined by a dark, smooth and perfectly adherent film.

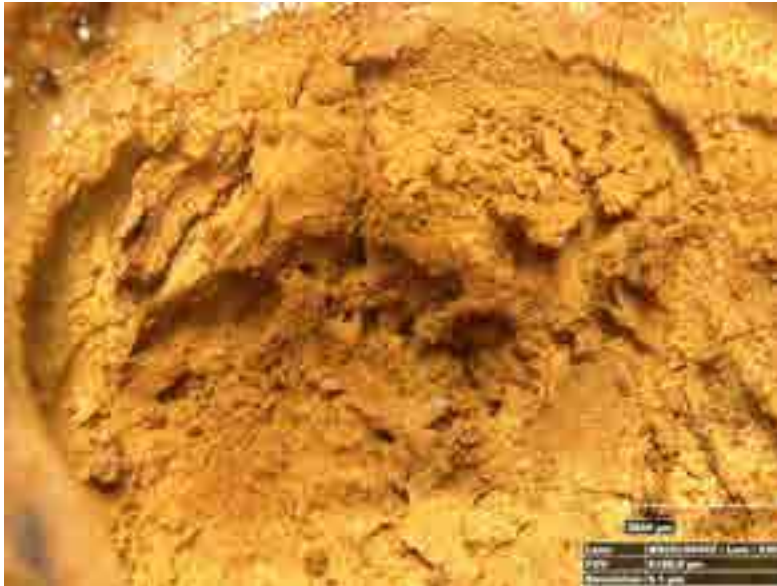
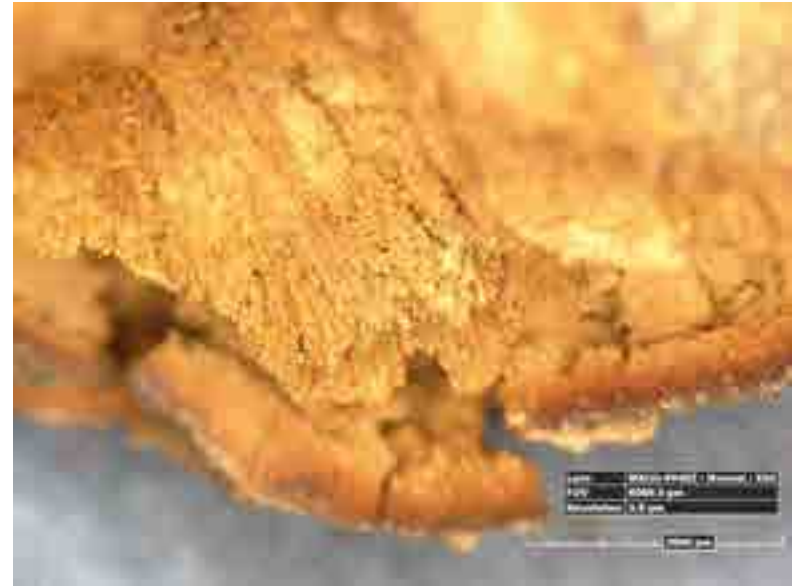
Canals and growth directions

Orifices appear on the top of the inside dome. The spongelike core has distinct growth directions. Different structural levels can be identified by different color nuances.

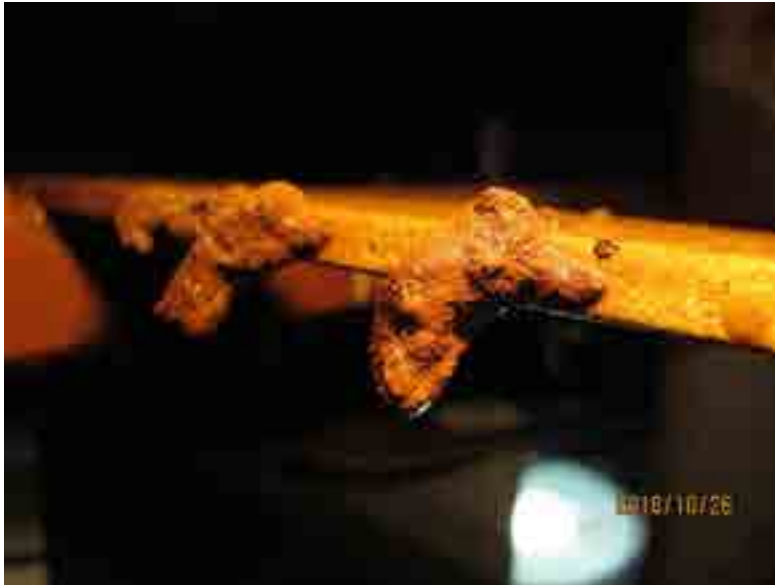
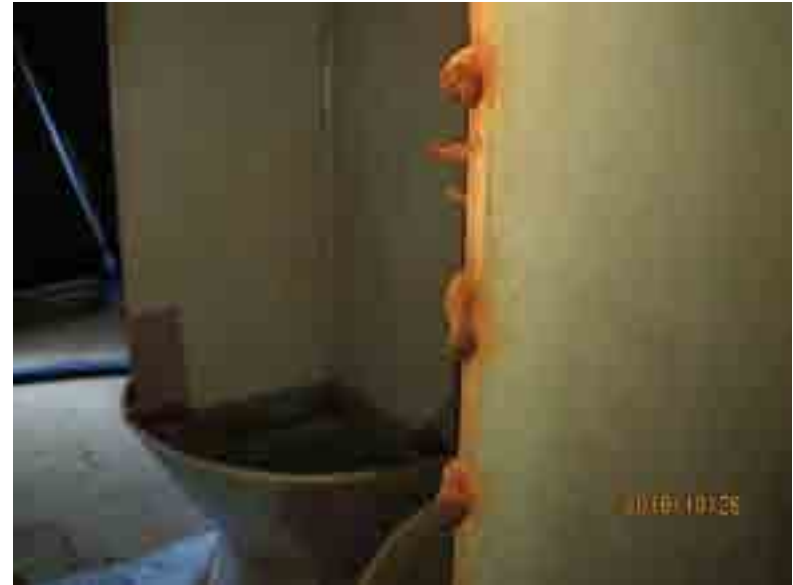
MIC in the fire protection system

A more aggressive type of MIC is encountered in the open tanks of the fire protection system. Here we find distinct, big tubercles which appear to be randomly distributed, although preferentially on sheltered places. The form of the tubercles is often elongated, like big slugs, and can protude well beyond the solid support on which they stand. The base material is painted carbon steel. The environment is industrial water.

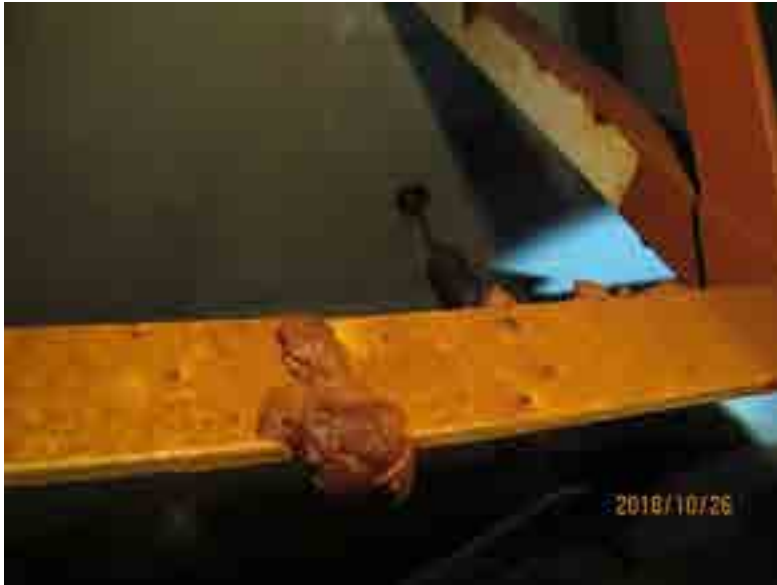
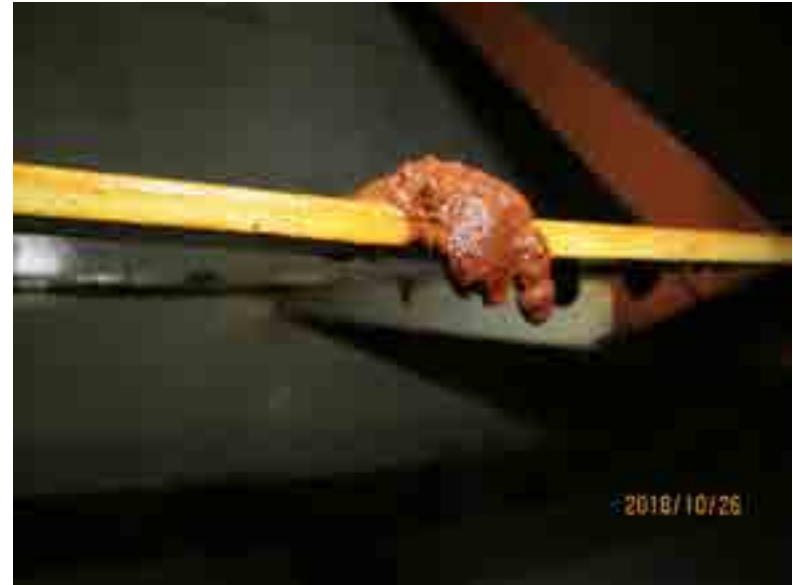
Protuding tubercles

The tubercles may develop and protude well beyond the metal surface from which they assume their building material. The feature is suggestive of an advanced transport system supporting the metabolism of the tubercles.

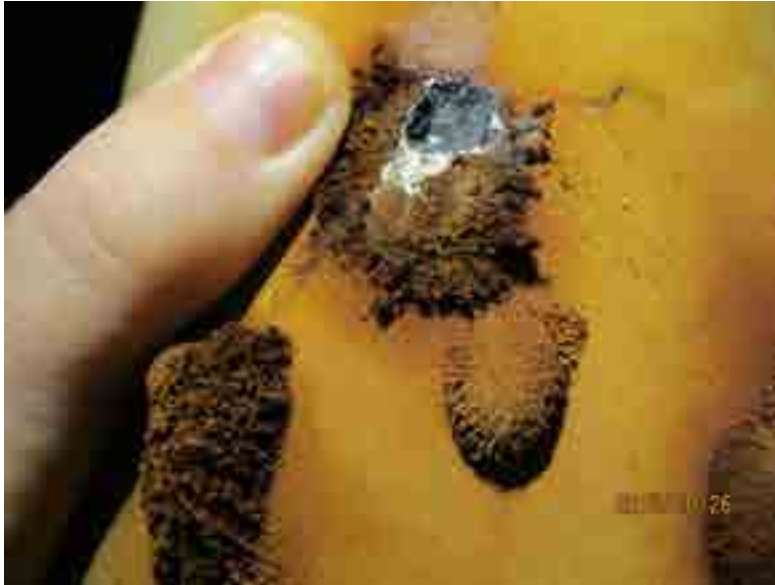
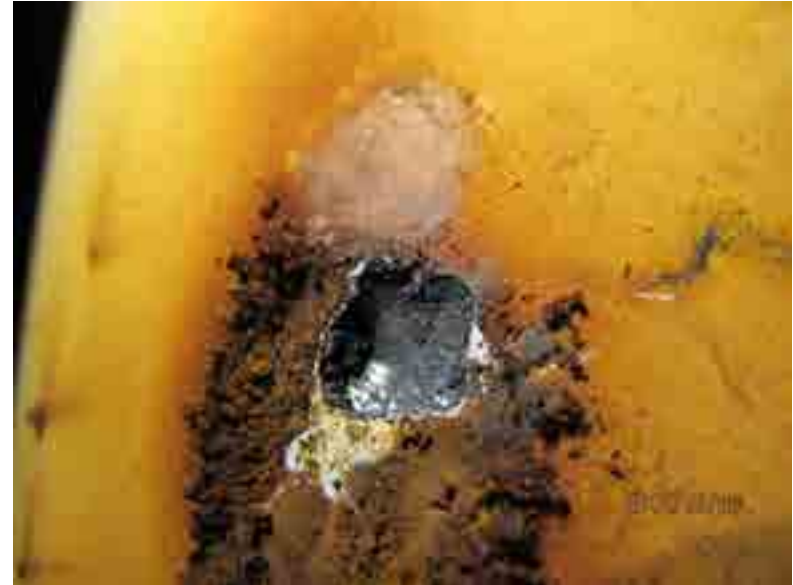
Deposits of black and soft iron(II)-compounds

The degradation of the base material is concentrated on a limited spot under the body of the tubercle. The material damage is significant. At the bottom of the corrosion holes are found deposits of black and soft iron(II)-compounds. The size of the corrosion holes appear to be related to how big the tubercles are. The dark holes are probably colonized by sulphur reducing bacteria, SRB, which "dig out" iron(II) ions from the base material. Those ions are then metabolized by the iron oxidizing bacteria which build up the red body of the tubercles.

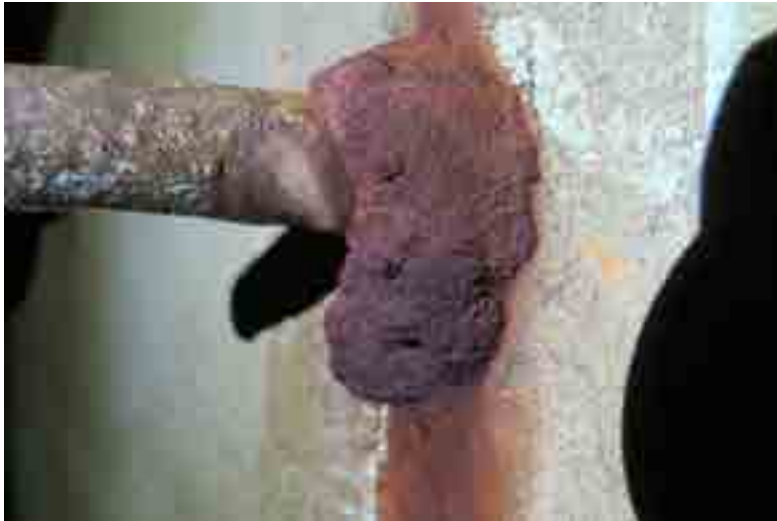
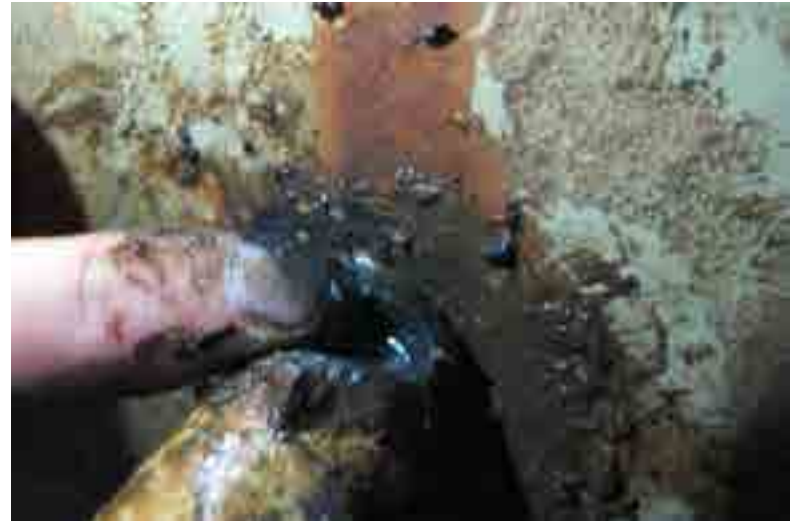
A big hanging "slug" dugged a deep corrosion hole

This remarkably clinging specimen has dugged a 5mm deep hole on top of its support

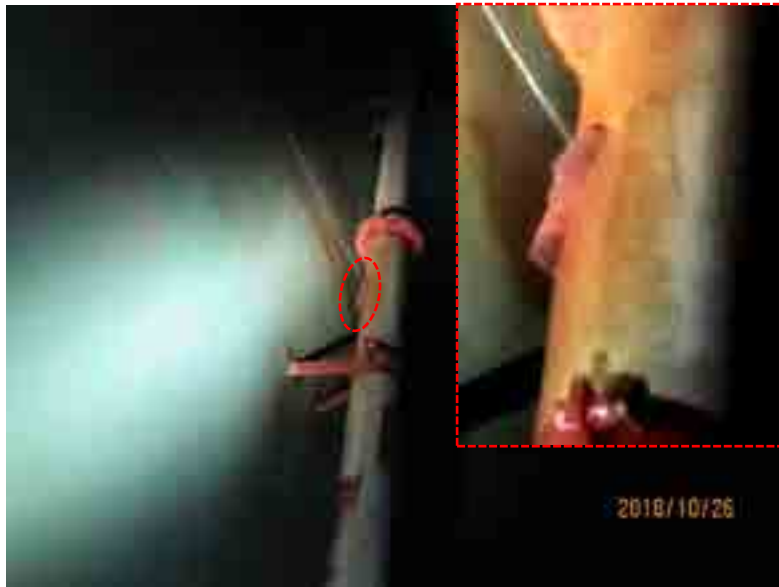
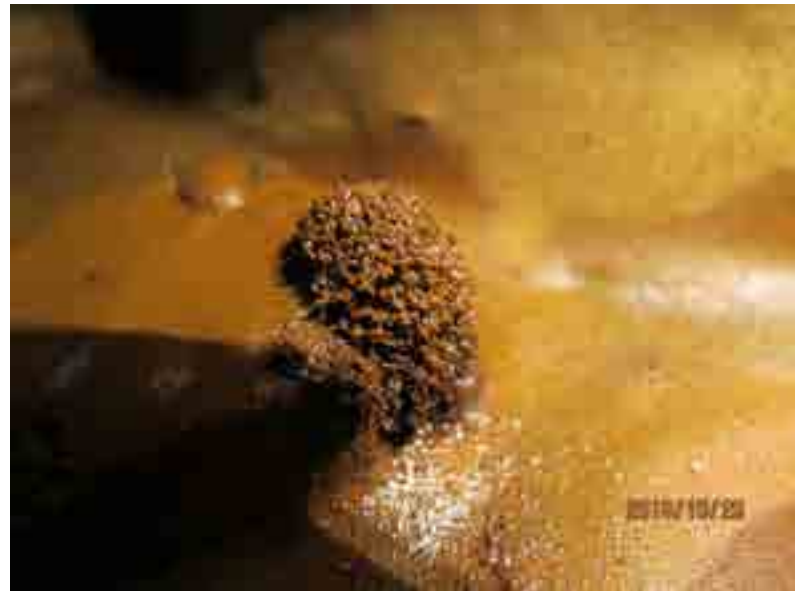
Some solitary specimens

A big, elongated tubercle in a solitary position far away on a pipe wall. And a small tubercle on a screw head

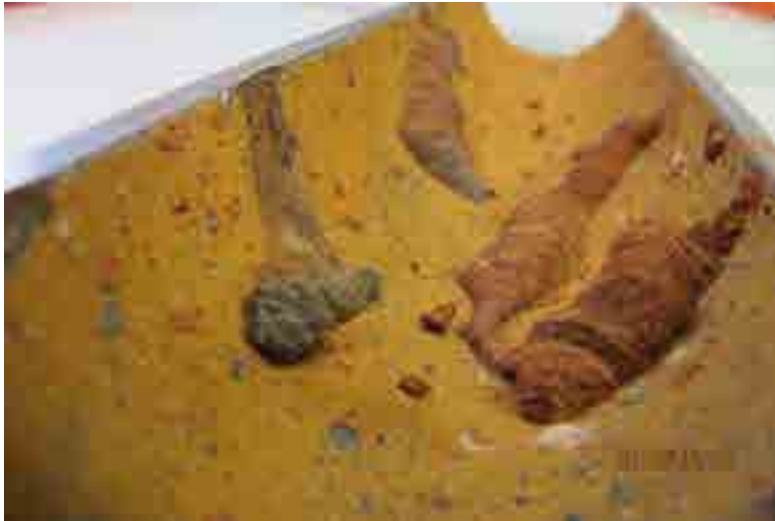
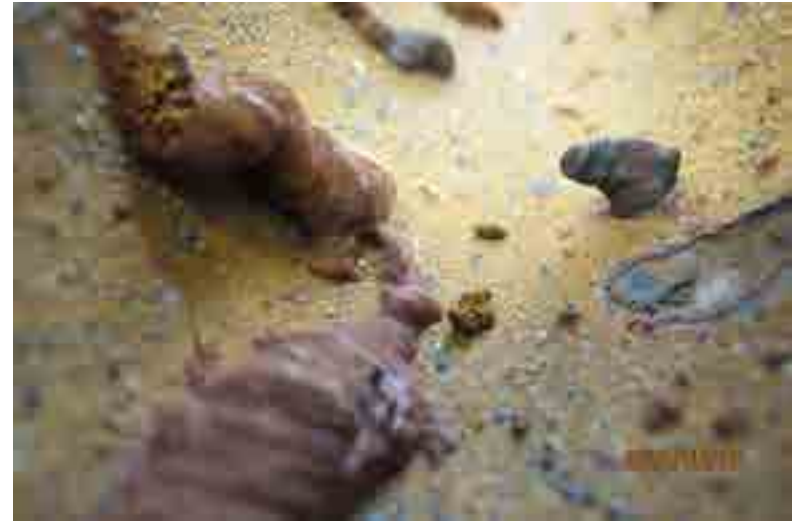
The pressurized part of the fire protection system

Out in the tube system the water pressure rises to 20 bar and the oxygen level becomes much lower then in the open tanks. The base material is galvanised steel. Here the MIC tubercles take on a different habit: they are relatively small and homogeneous in some of their size parameters. They have hard shells and hard cores. The depth of the corrosion holes appear to be related to the hight of the tubercles. The corrosion rate appear to be constant and relatively slow..

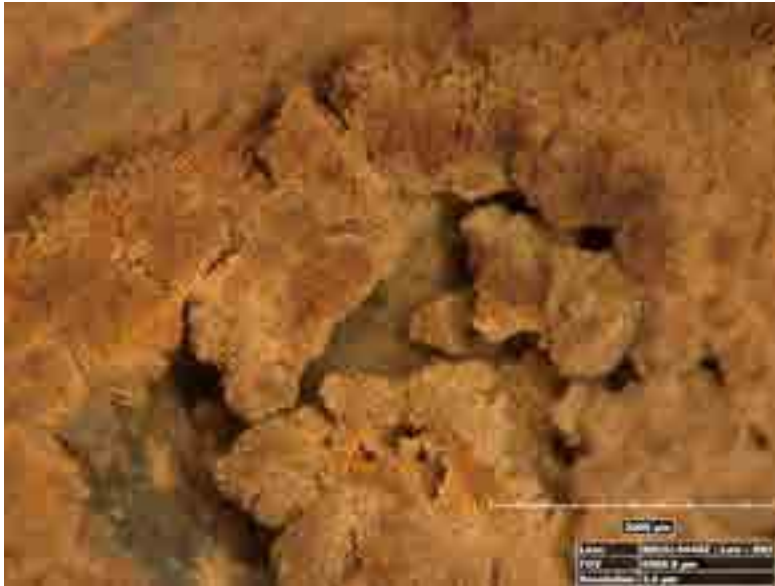
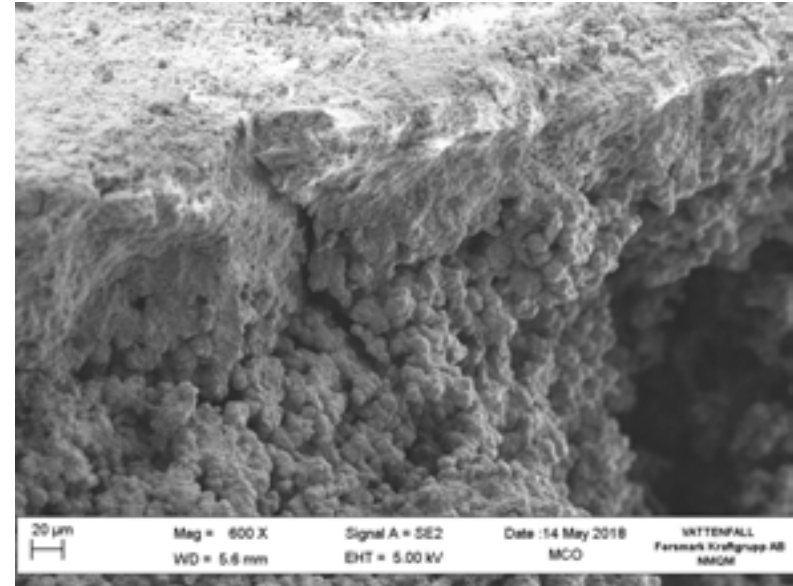
Thick shell and hard spongy core

Evidence for MIC is given by the spongy appearance of the core material of the tubercles. At higher magnification the biogenerated microtubes are clearly identified, although the picture on the right gives the impression of higher density and sharper angles than expected.

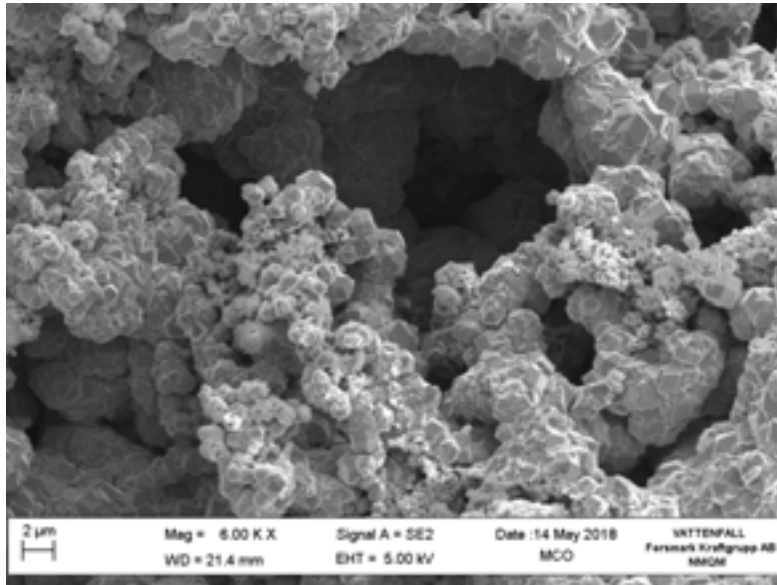
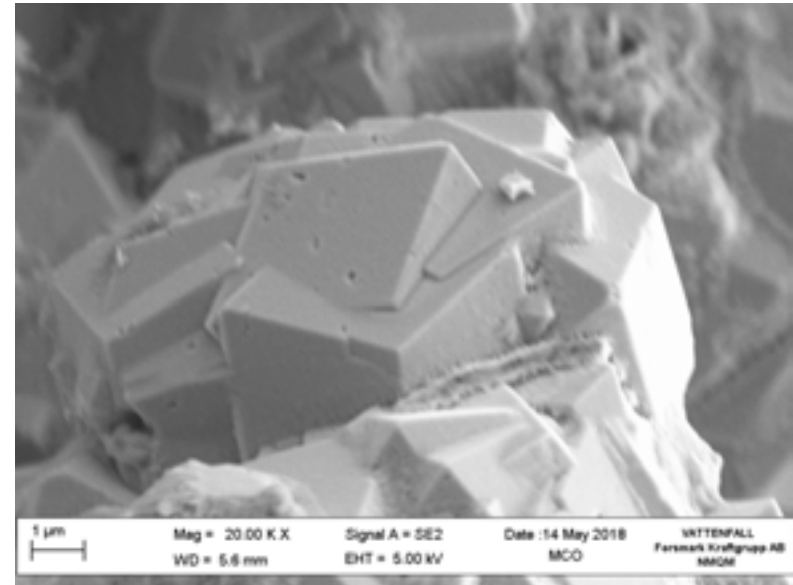
Advanced state of crystallization

At even higher magnification the microtubes look kind of fossilized. The originally biogenic Fe(III) Oxide-structures appear to have undergone a further process of mineralization.
