# MAUT

Matrix Array Ultrasonic Testing

Transducer Technology

dolphitech

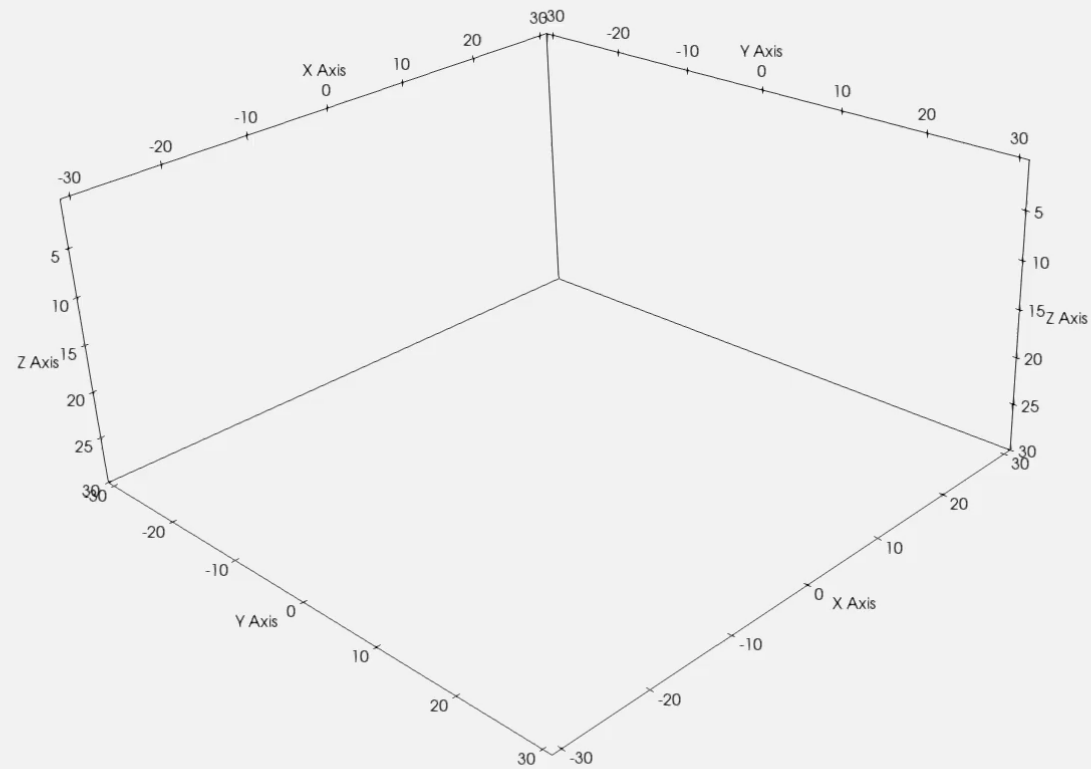
# Sound Field Profile

## 3D-Simulation 4 Transmit Electrodes

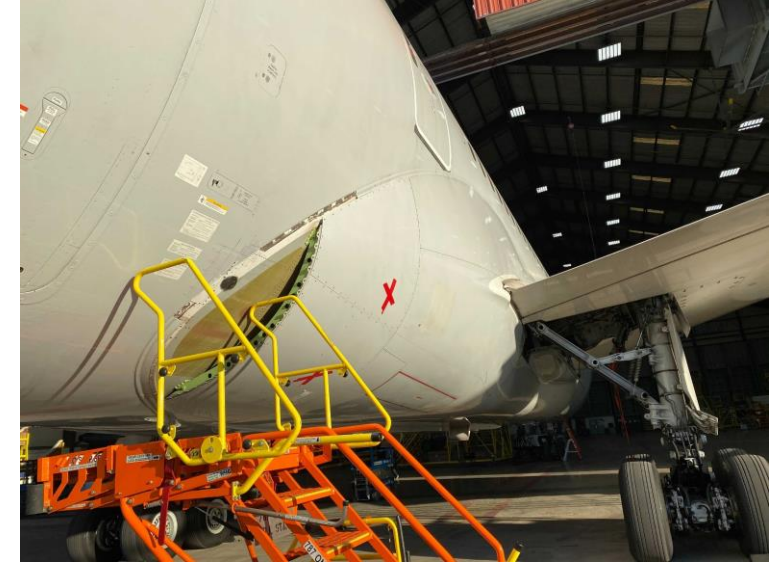
– Aircraft photograph

- Impact event on the fuselage of a Boeing 787 Dreamliner
- 480x480mm area mapped with the dolphicam2
- Main impact zone and disbanded stringer clearly visible

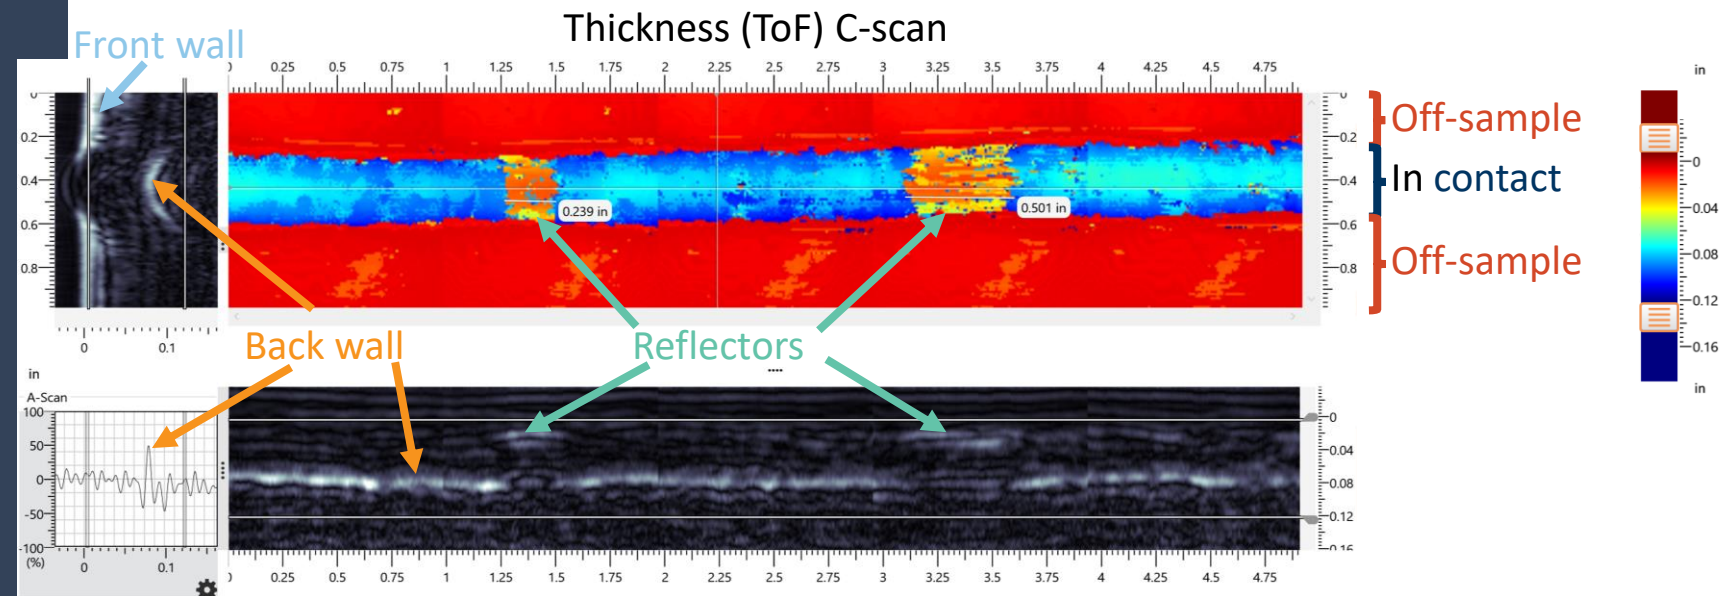
# CFRP radii

- Tight corner radius of 0.09" thick carbon fiber laminate.
- Nominal radius of curvature is 0.3125" (~8mm).
- Circular reflectors are embedded, which are nominally 0.25" and 0.5" in diameter.

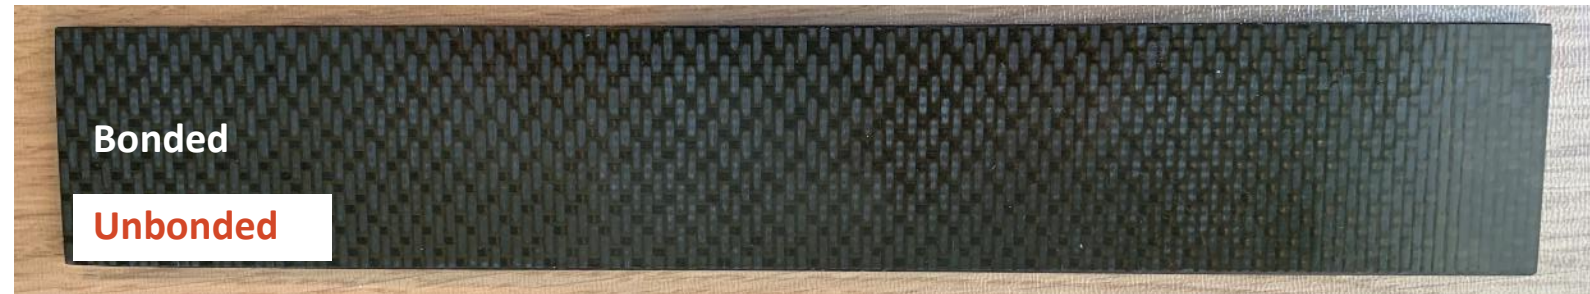
– Inspection face

- 2mm thick woven CFRP with six different material tiles adhesively bonded to back face
- Half of each tile is bonded, half is left unbonded
- Difference between bonded and unbonded is clearly visible for all tiles
- Each tile has a different characteristic bonding signature enabling material discrimination
