Microbiologically induced corrosion in cold systems at Forsmark NPP

FOP 7-9 april 2019, Västerås

Massimo Cocco – FKA Material Analysis

Pär Blombergsson – FKA In Service Inspection

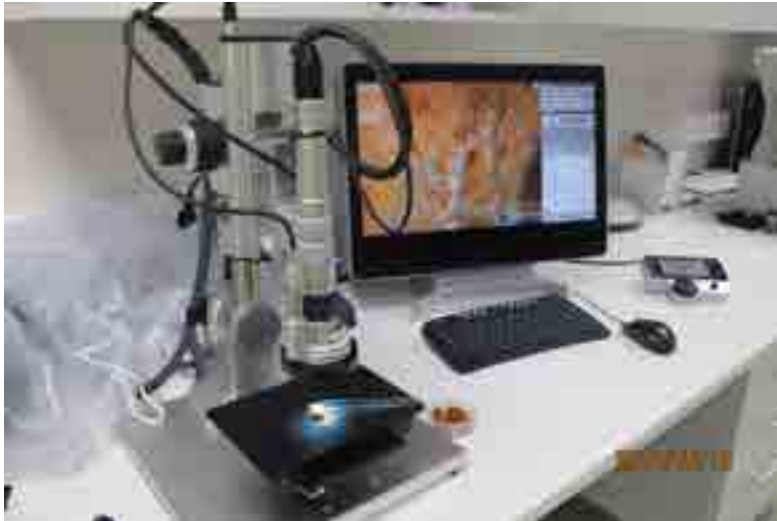
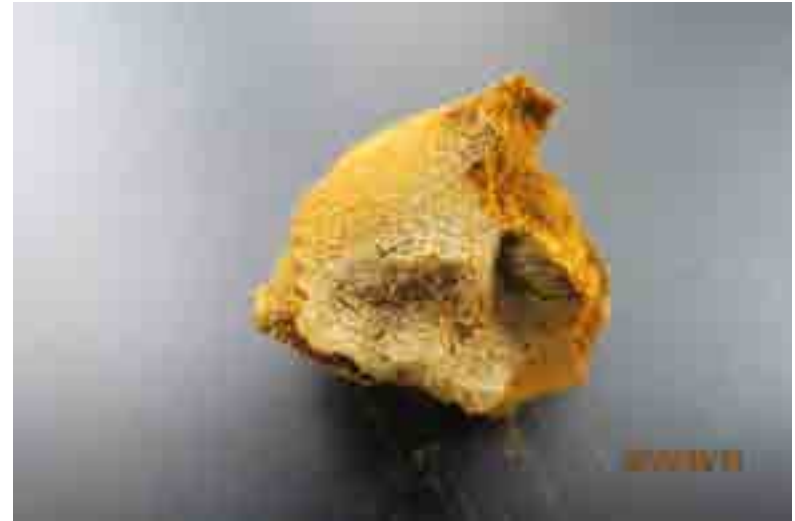
At a closer look many other interesting features are disclosed

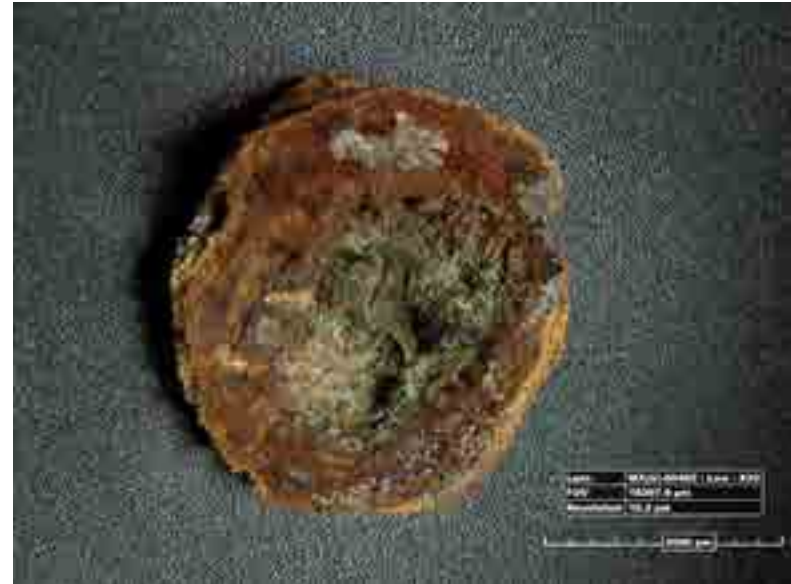
Element	Wt%	Wt% Sigma
C	6,08	0,79
O	32,82	0,89
Si	0,7	0,11
S	4,75	0,62
Cl	0,82	0,17
Cr	37,64	1,12
Mo	17,19	1,52
Total:	100

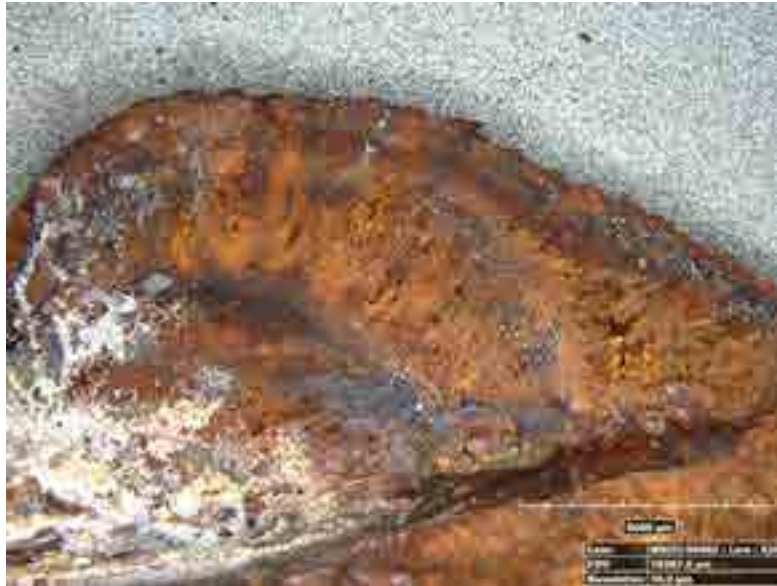
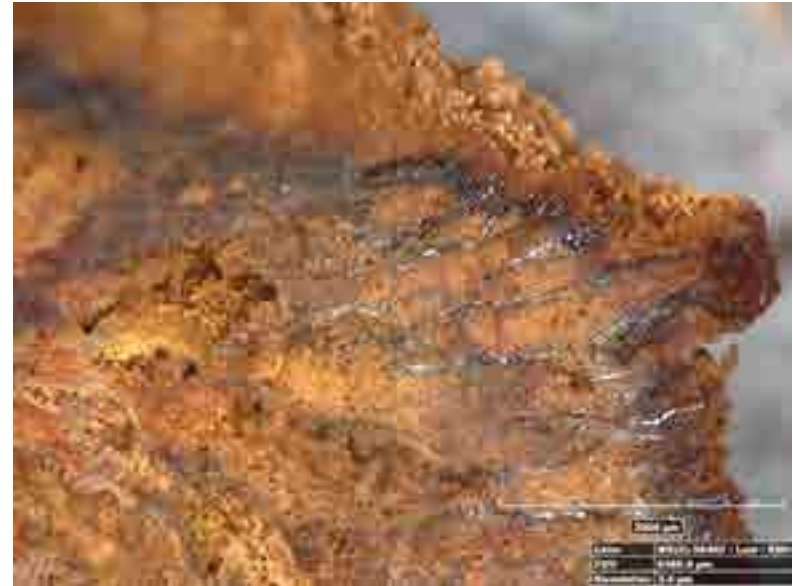
Complex structure

An ordered pattern of thin magnetite walls builds up a complex system of adjacent cells

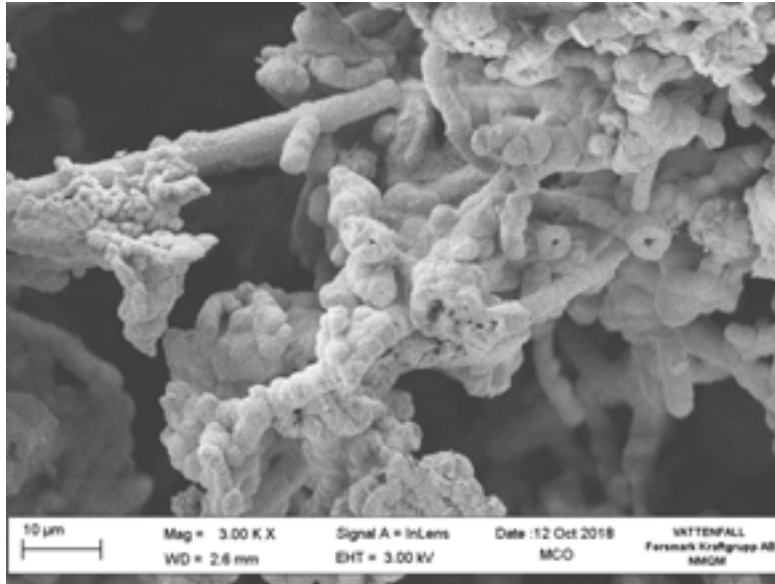
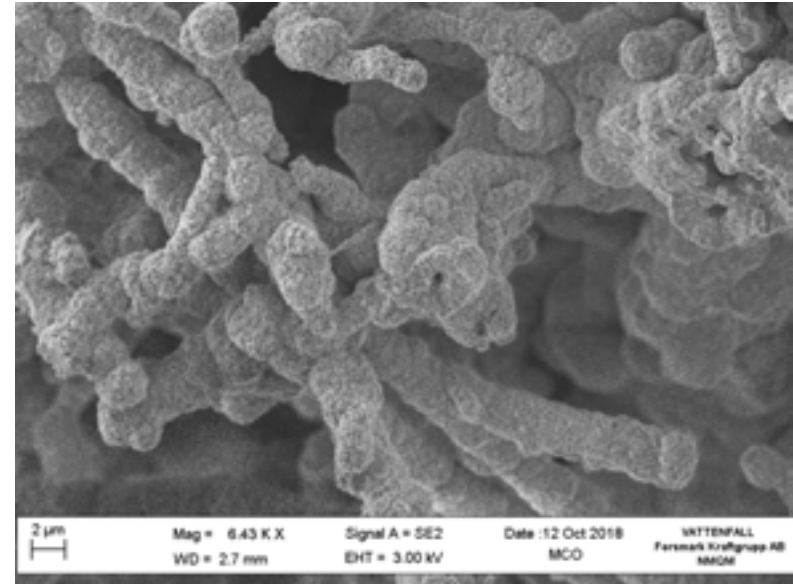
Biogenerated iron(III)oxide-structures

In the scanning electron microscope the biogenerated features of the corrosion tubercles are displayed in an astonishing richness of details

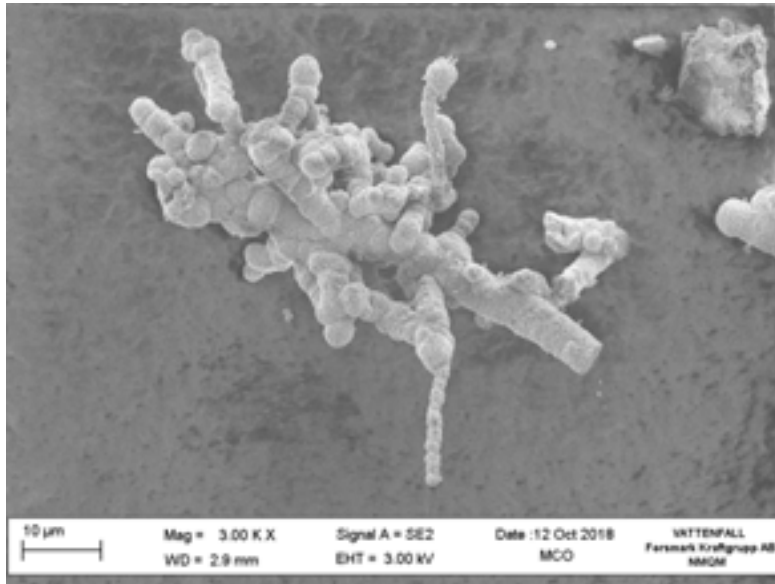
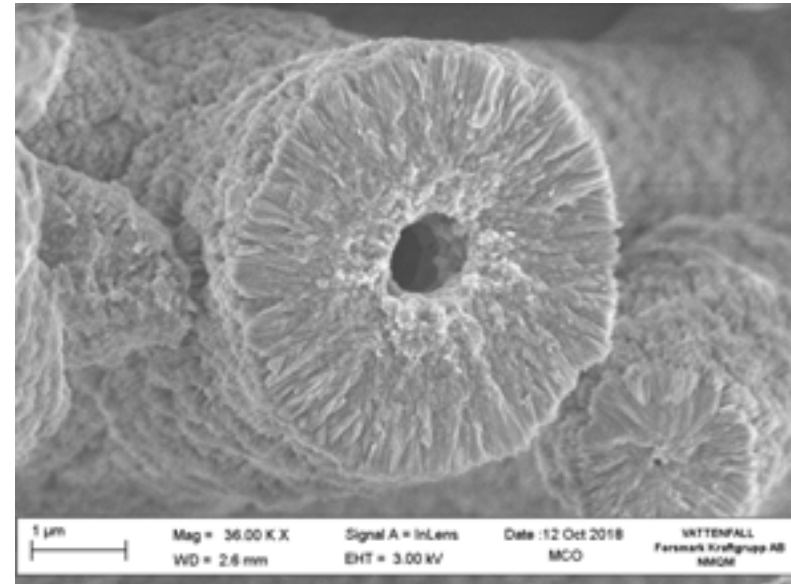
Hollow microtubes

The spongelike core material of the tubercles is build up by an intricate network of hollow microtubes. Iron(III)-oxide is crystallised radially around the bacteria in the process building up the microtubes

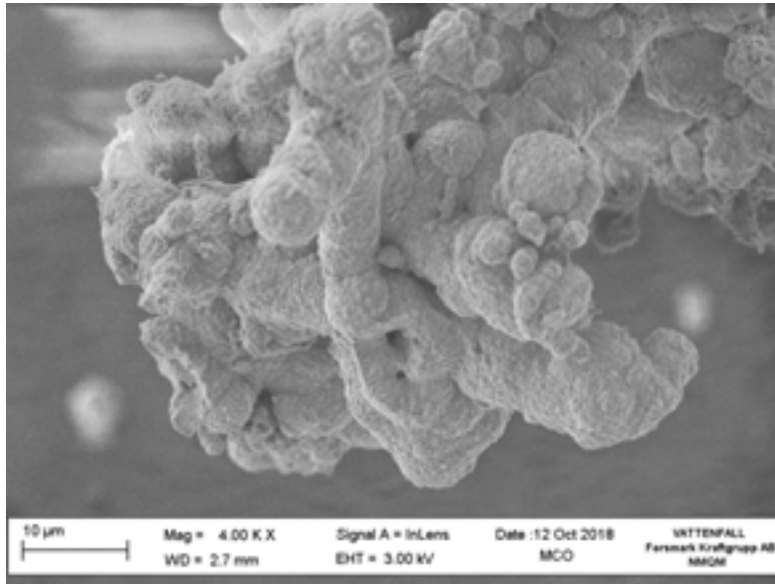
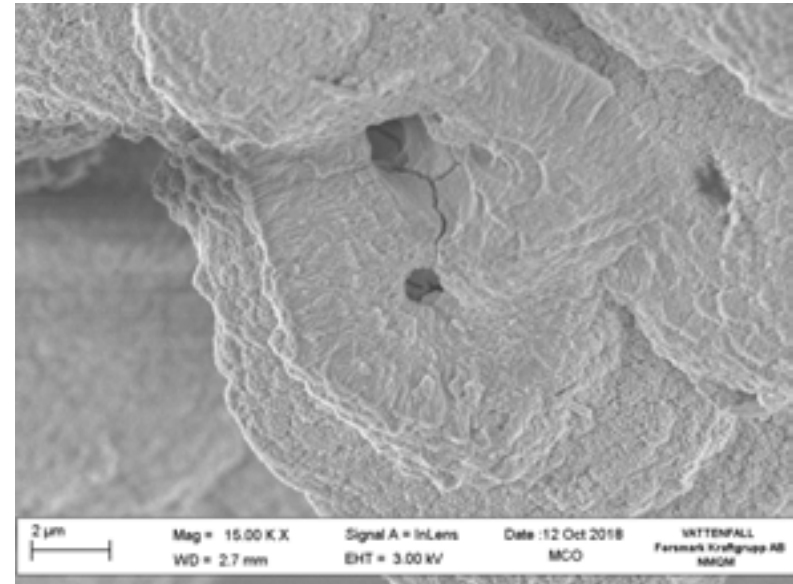
Biomining

The iron oxidizing bacteria take up the energy contained in the metal and return it to a mineral compound

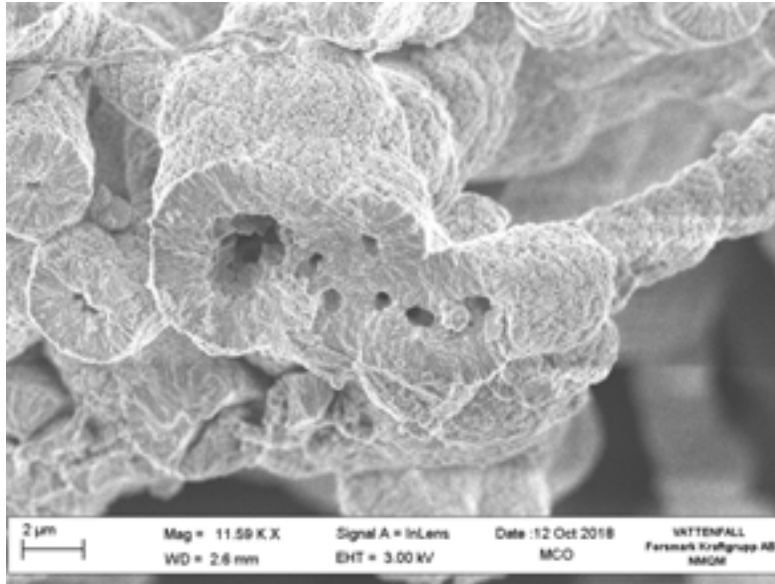
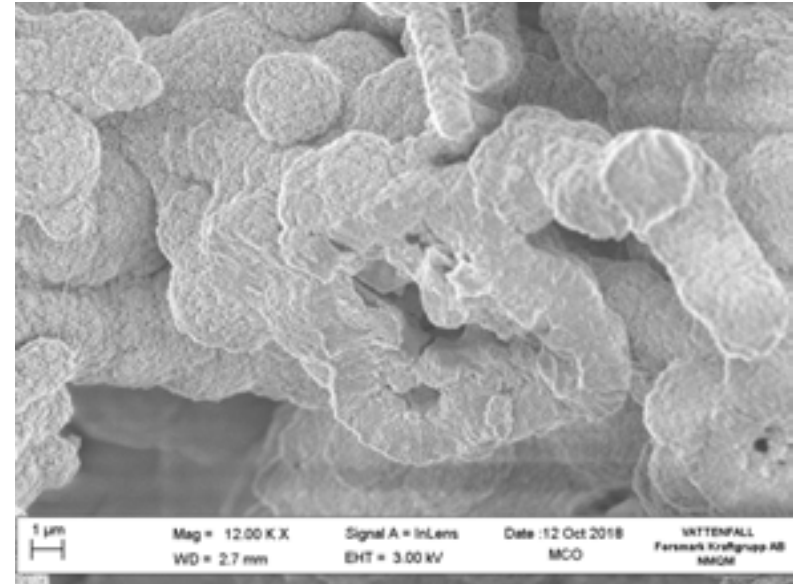
Life is way of sustaining energy dissipation

By building up complex solid structures the bacteria obtain a selfsustaining dynamic system which optimize the flow of metabolites and maximize the energy uptake from the base material. That's way MIC may results in substantially higher degradation rates as compared to trivial cases of pure electrochemical corrosion.

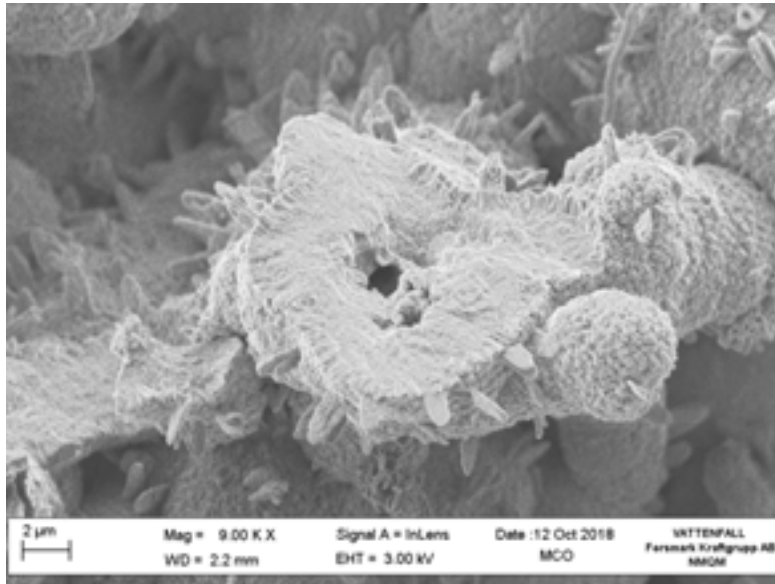
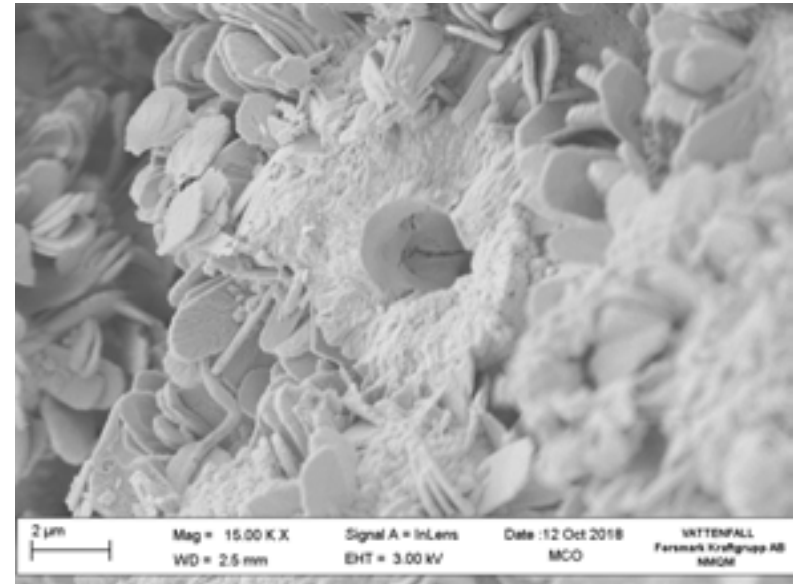
Different features - different functionality

In some regions the microtubes are equipped with small plates

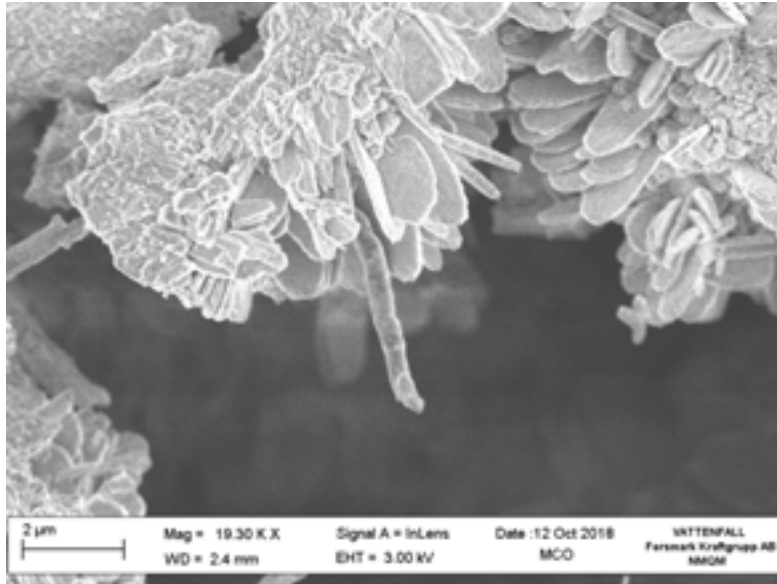
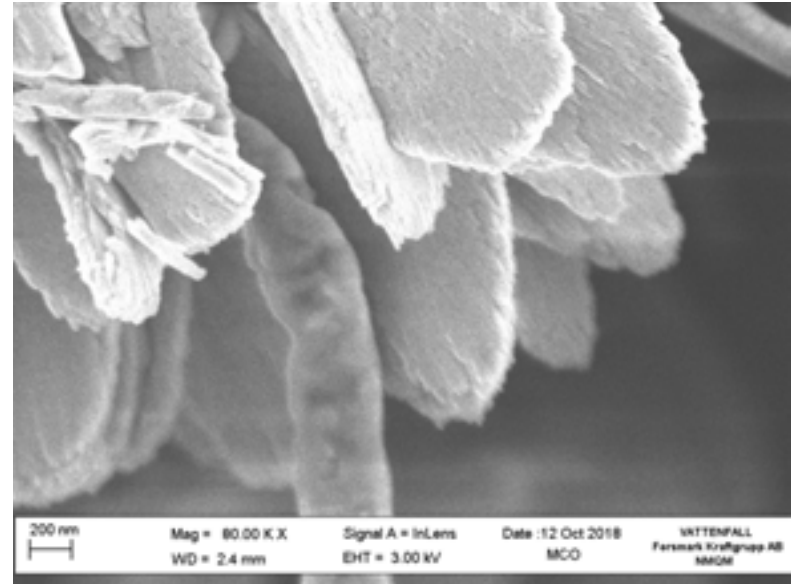
Iron oxidizing bacteria

The pictures below catch a bacteria emerging from in between a group of plates

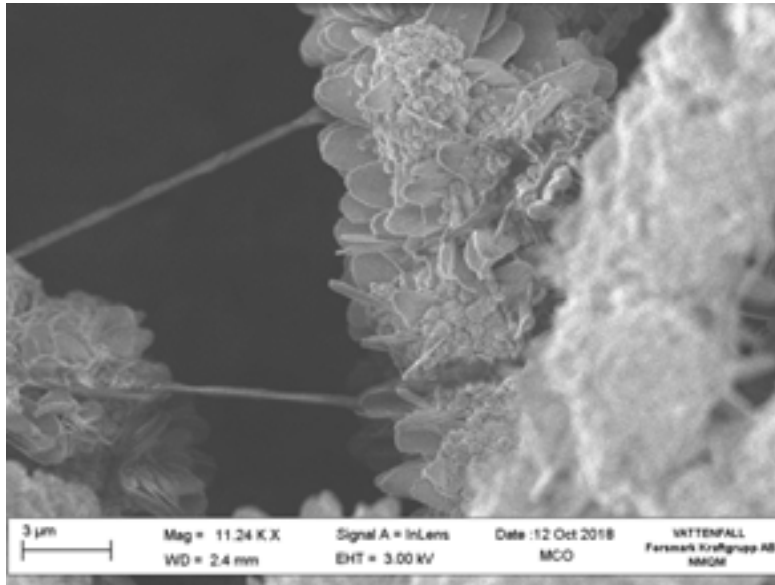
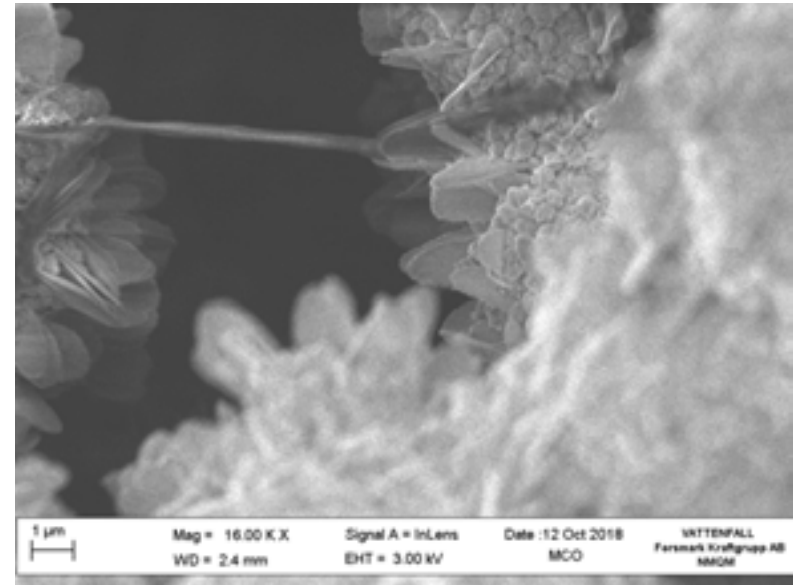
Bacteria elongating from in between a group of plates on a microtube to the microtube next by. What's going on?

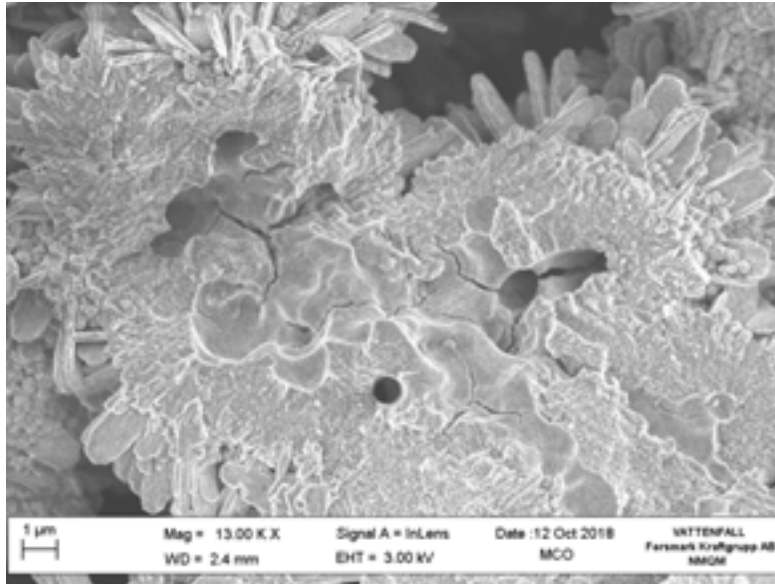
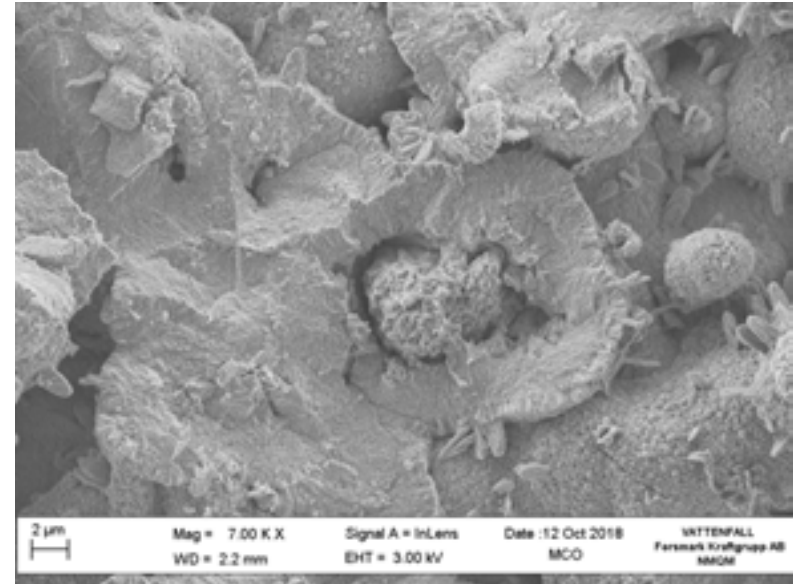
Further features yet to be understood

Deep buried into a system of merging hollows is observed a porous structure. The richness of features observed gives clues to a complex biological system yet to be understood

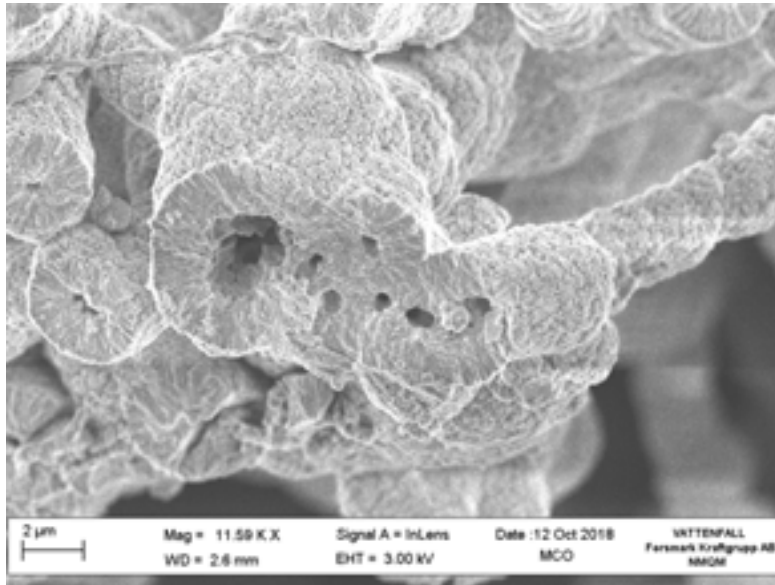
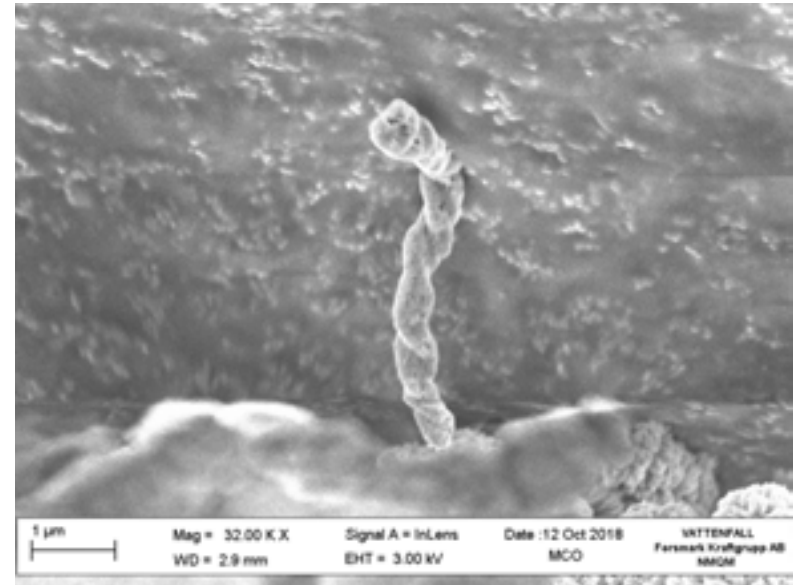
MIC diagnosis

The twisted shape of the bacteria caught in the right picture suggests that it may belong to the iron oxidizing species *Gallionella Ferruginea*

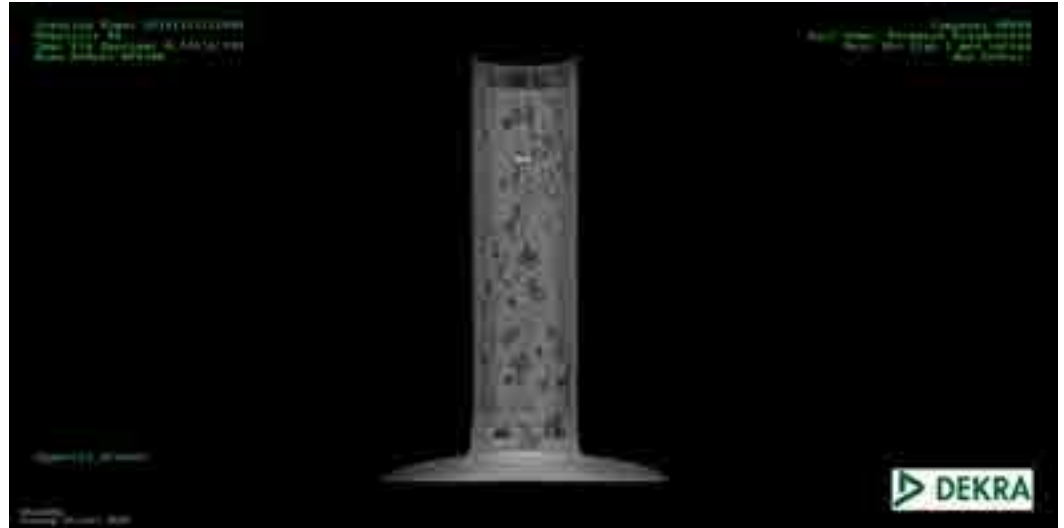
Digital x-ray

- Screen size ca 500mm
- Voltage up to 300kv
- Online evaluation
- Conventional x-ray equipment
- Need safety zone
- Ca 50-100 pictures in 8 hours

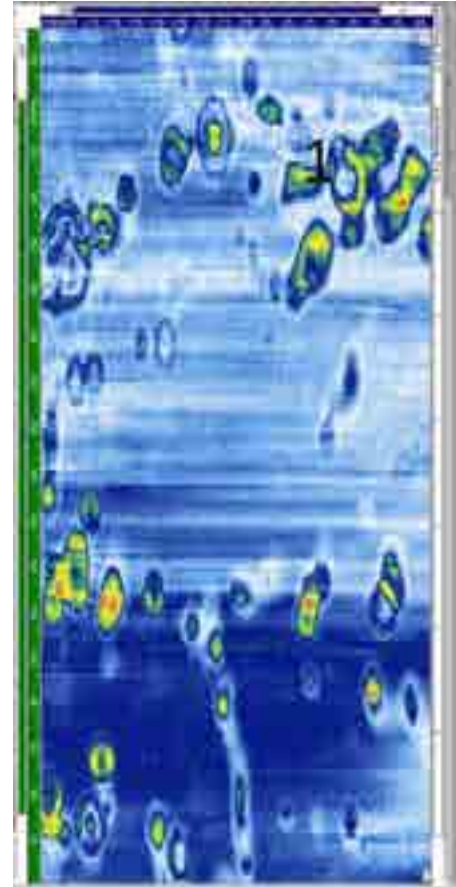
Mechanised ultrasonic Testing

- Loss of bottom echo due to scanning
- The problem could eventually be solved by using focused probe
- Small pipe diameters and thin pipe walls limit the applicability of UT

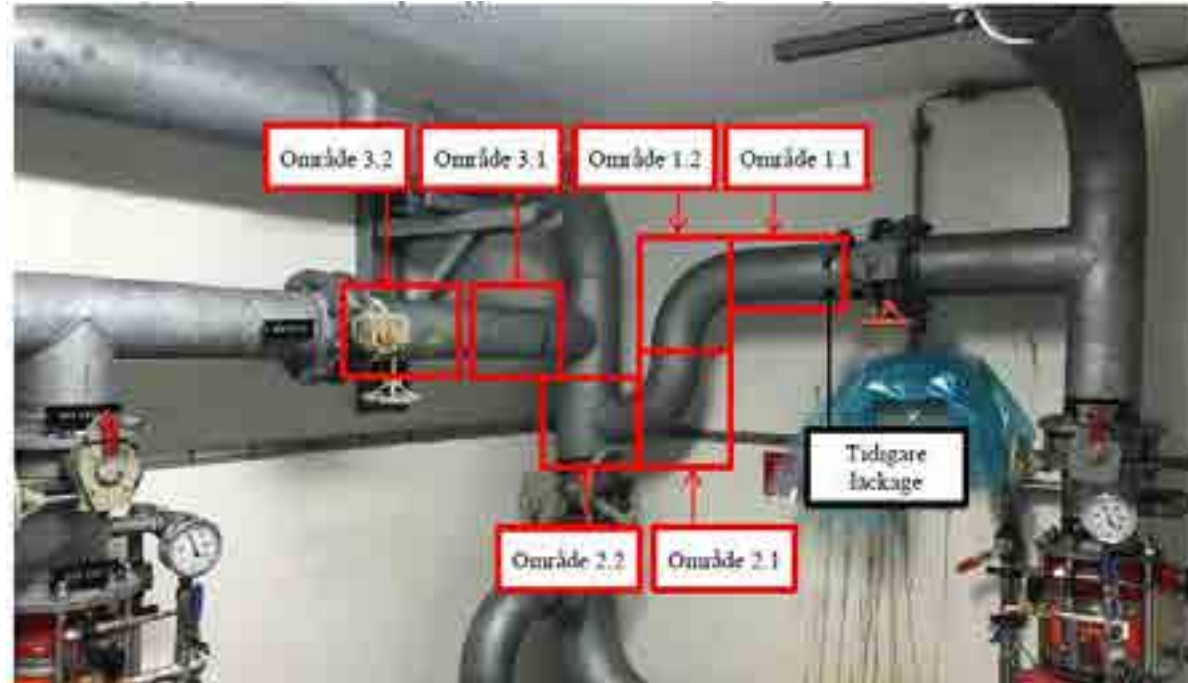
Real case 2019

- Pipe diameter 150mm to 200mm
- Waterfilled
